Biofilm in an aseptic production facility

A case study of spoilage diagnosis & eradication

Mike Bolstridge
Director :Product Quality & Safety
Tetra Pak Inc

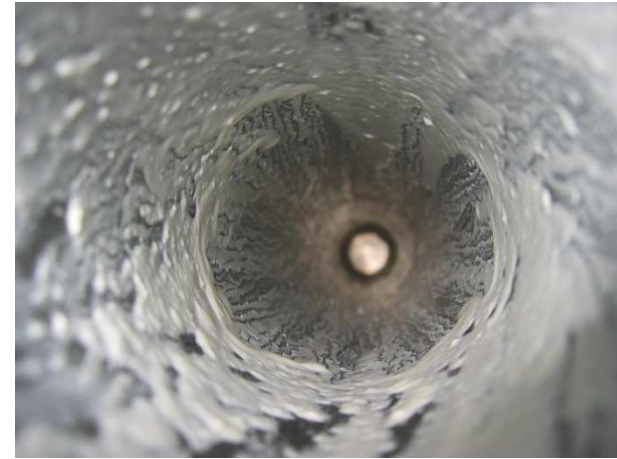
Aseptic damper on aseptic homogenizer before CIP.

Cleaning inadequate.
Recommend extra manual
cleaning of dampers.

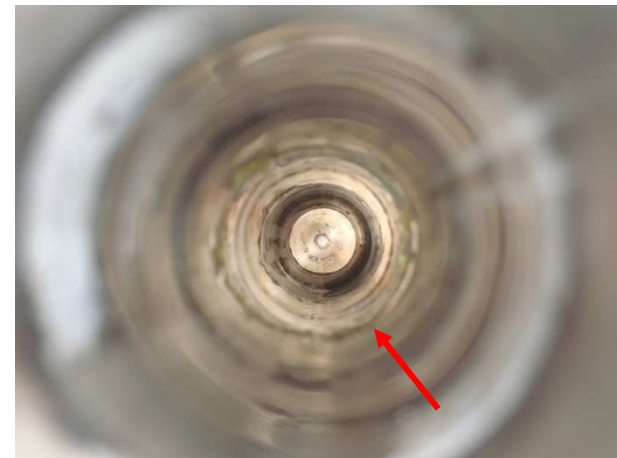
Aseptic damper after CIP – residues still visible.

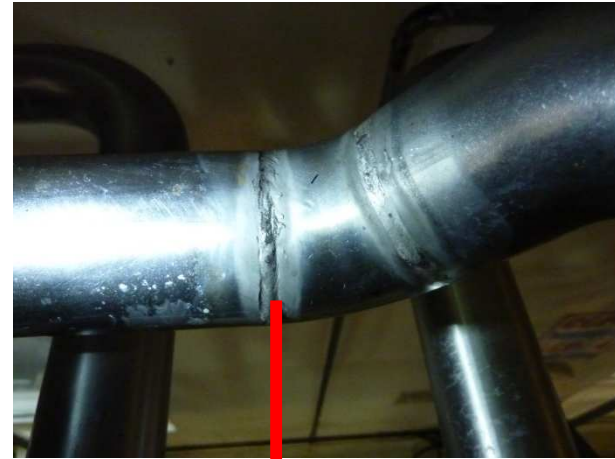
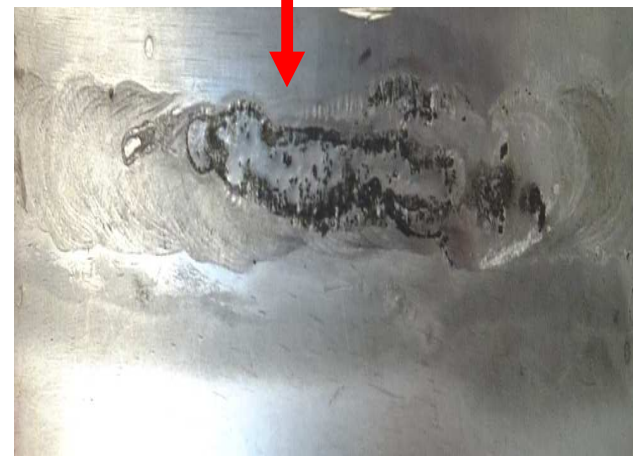
Welds on product lines to fillers are not good when viewed from the outside.

When these pipes were cut open, these welds were extremely rough on the product contact surface. They pose a challenge to achieve thorough cleaning and therefore will support the development of biofilms in these areas (**weld located on product line immediately before product inlet valve on filler 4 on right.**)

- Re-direct airflow in Filling Room to avoid excessive condensate build up on idle fillers
- ✓ Check all welds on product lines to all fillers – replace pipes if necessary (line 4 completed)
